TEST REPORT

SLIP RESISTANCE CLASSIFICATION OF
NEW PEDESTRIAN SURFACE MATERIALS

AS/NZ: 4586.2004

Haven Collection, Dark Brown, Timber Flooring

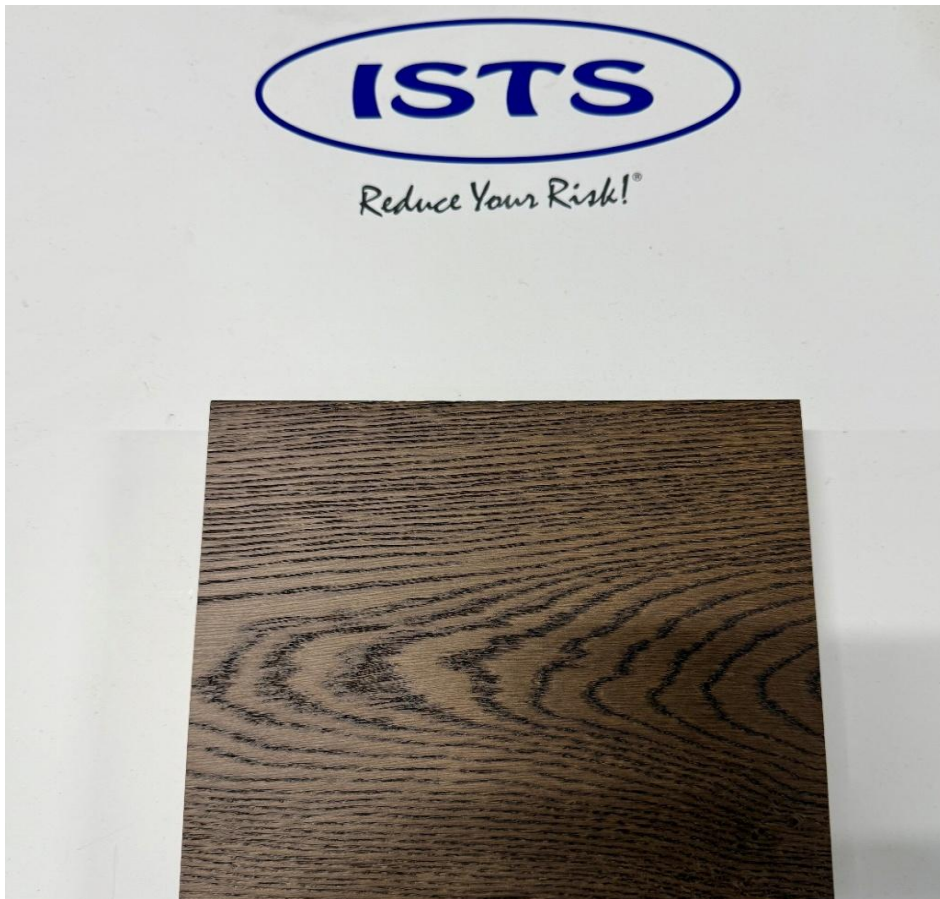
TEST PRODUCT IMAGE

Product Description: Haven Collection, Dark Brown, Timber Flooring

Test Date: 05-12-2025

- 1x Haven Collection, Dark Brown, Timber Flooring, Sample Size 20x20cm
- 1x Haven Collection, Dark Brown, Timber Flooring, Sample Size 20x20cm
- 1x Haven Collection, Dark Brown, Timber Flooring, Sample Size 20x20cm
- 1x Haven Collection, Dark Brown, Timber Flooring, Sample Size 20x20cm
- 1x Haven Collection, Dark Brown, Timber Flooring, Sample Size 20x20cm
