# TEST REPORT

## SLIP RESISTANCE CLASSIFICATION OF NEW PEDESTRIAN SURFACE MATERIALS

**Forte**

**Millboard Collection, Enhanced Grain (EG), Grey.**

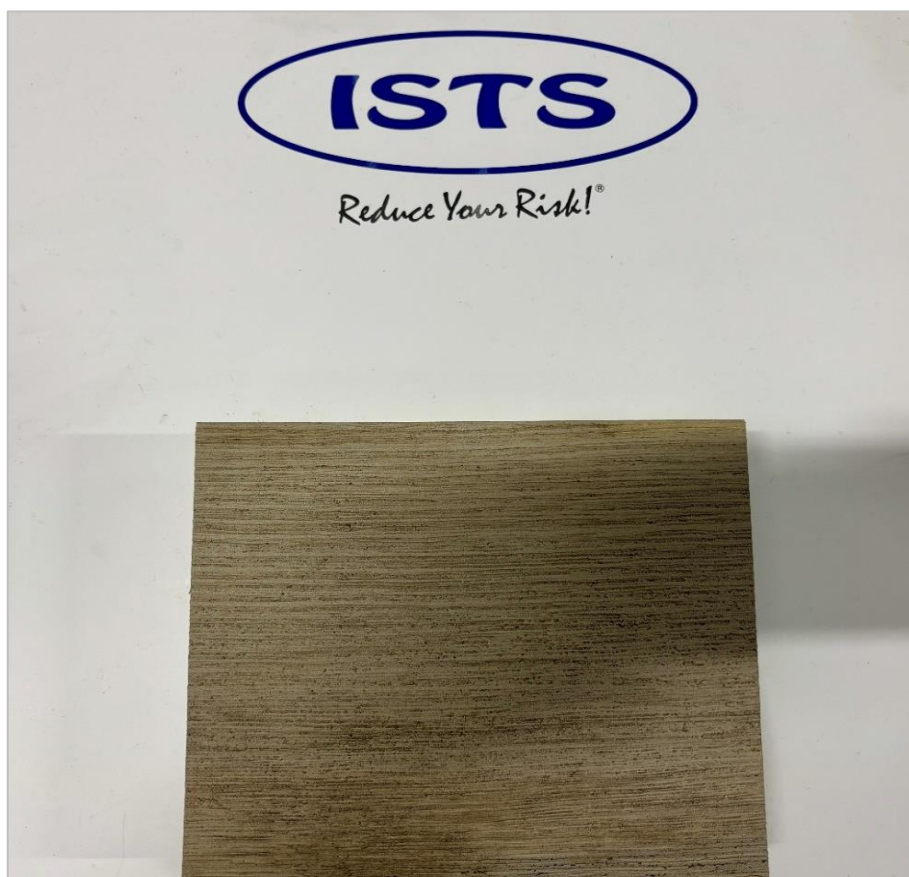
## TEST PRODUCT IMAGE

**Product Description:** Millboard Collection, Enhanced Grain (EG), Grey.

**Test Date:** 02-12-2025
